# A Case Study on the Fire Safety in Historic Buildings in Slovakia

*Agnes Iringová*

## Abstract

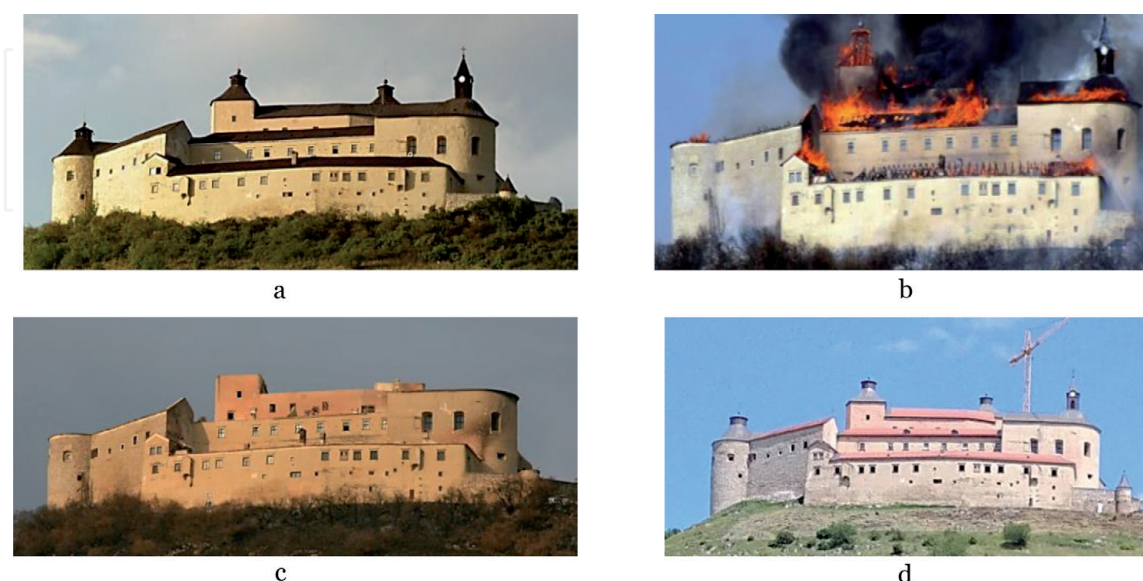
**Figure 1.**  
 The castle of Krásna Hôrka before fire, during fire, after fire and at the present time. (a) Original castle timber roofs before fire in 2012; (b) fire in the castle in 2012; (c) the castle after fire in 2012; (d) the castle at the present time.

Here is the example of fire in the castle of Krásna Hôrka from 2012. The fire progress is shown in **Figure 1b**. Fire was caused by children who carelessly handled free flame near the castle hill. They threw a burning object into dry grass that ignited. As there was strong wind, fire spread rapidly onto the combustible castle roofs covered by wooden shingles (see **Figure 1a**). The castle consists of three buildings. The original upper castle dates from the fourteenth century; the middle and lower castles were built later by the original owners. The castle housed a permanent display of period works of art giving basic information on the castle and its original owners. There were original exhibits with a high museum value. The original roof structure consisted of timber trusses covered with wooden shingles and took the area of about 5000 m<sup>2</sup>. The lower and middle castle has vaulted ceilings; the upper castle has steel-bearing ceiling structure with a wooden flap. The castle has stone and brick external walls.

The fire lasted for about 3 days in terms of the quantity of timber structures and unfavorable natural conditions—strong wind. The roofs burned down (see **Figure 1c**). The firefighting was slowed down due to the road that was badly accessible for the fire brigade—there is only one access road leading to the castle. The water source was far from the burning area, and it was not possible to use the water reservoir in the castle.

Nowadays, the castle's restoration is coming to an end. All roofs, including load-bearing and truss structures, were built as replicas of the original structures, taking into account the forms they had at the time of the last major castle's style alternation after fire in 1817 (1818). The original wooden shingle roof is replaced by burnt ceramic roofing, and the bastions have metal roofing (see **Figure 1d**). In this case, fire was caused by negligence and climatic conditions.

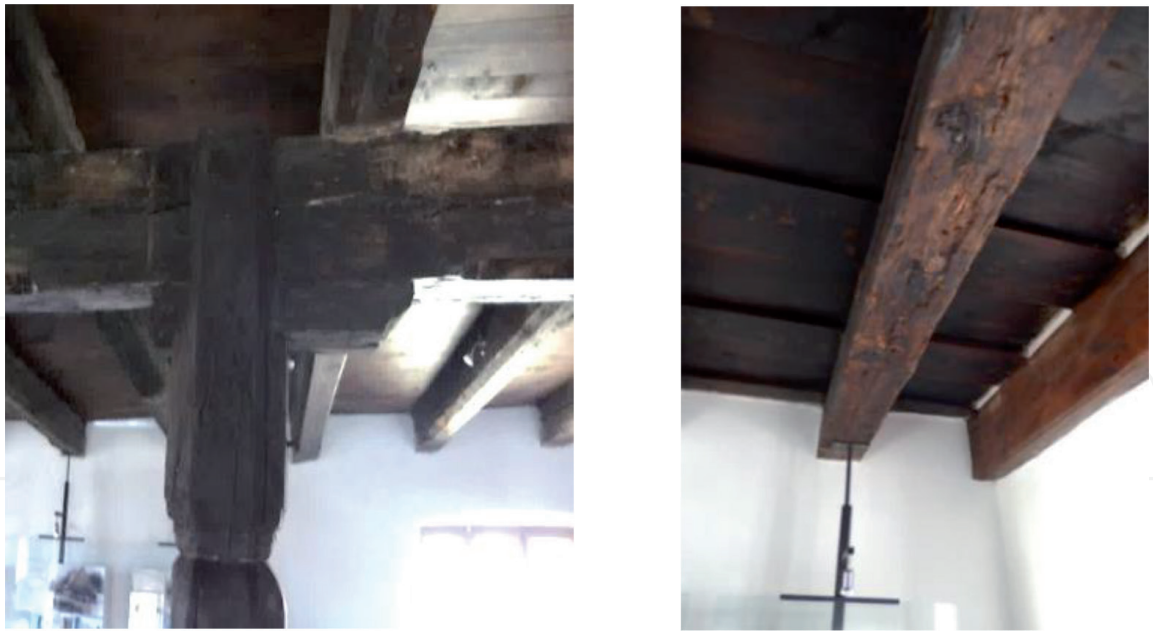
**Figure 4.**  
*Supporting using a wooden beam and column (left) and ceiling wooden beam with a wooden decking (right).*

The fire resistance of wooden members affected by fire (wooden beam ceiling, column and girder) was specified using the effective cross-section method [7]. The methodology is based on the assumption that the first phase of burning wooden elements causes the surface burning and forms a carbonized layer. Such element becomes partially thermo-insulated by further thermal stress, which prolongs its fire resistance. The charring thickness is determined by the fire duration to which the element is exposed and by the charring rate. This interface or the location of the carbonized line in most coniferous and deciduous trees corresponds to the isothermal position of 300°C. After obtaining an effective cross-section, the element is assessed according to [8]. The method of reduced properties works with the residual cross-section (obtained after reading the carbonized layer) taking into account the changed strength and stiffness material properties based on the modified coefficient. In light of this assessment, all wooden load-bearing members in the assessed fire section of the museum met the required fire resistance without additional structural modifications.
